SALVAGE FISHERMAN'S MUSEUM

2021 BUILDING RENOVATIONS REPORT

Prepared by Maryssa Barras

Published Aug. 19, 2021

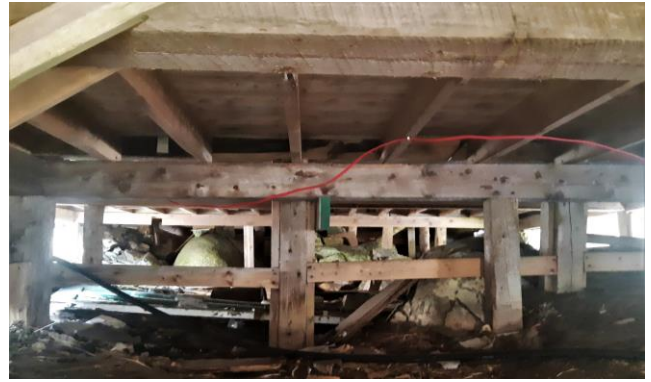
Image 3 (Top): View of the foundation between the historic and new portions of the building (Photo by Maryssa Barras 2021)

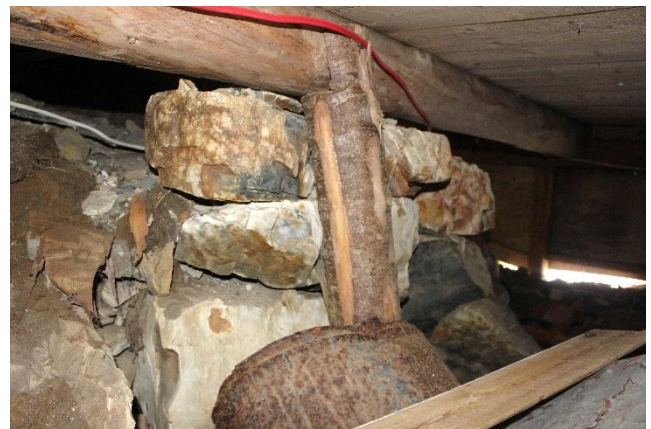
The foundation of the museum building was found to be in a severe state of disrepair during initial assessments. Barbour Services's inspection revealed that there were several loose and rotted wooden shores which would need to be secured or replaced to stabilize the building. From the exterior and interior of the building the impact of foundation settlement on the structure, including a distinct sag along the roof line, sagging in the interior floor, and a gap between the stone chimney foundation and the floor, was clear.

Image 4 (Second): Shore (Photo by Dale Jarvis, 2020)

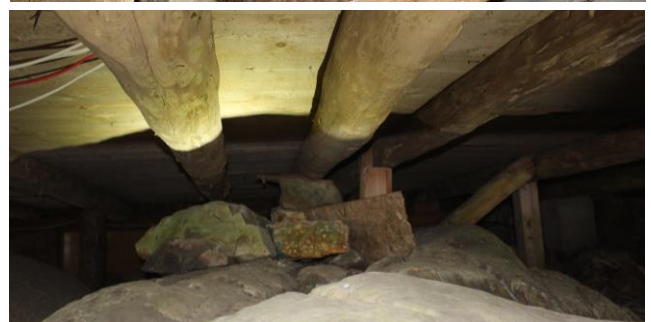
Image 5 (Third): Foundation stringers (Photo by Dale Jarvis, 2020)

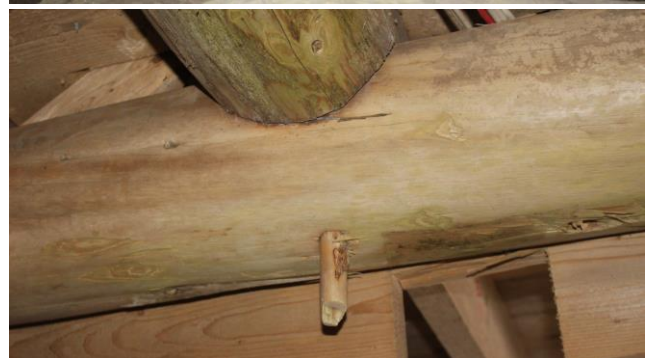
In their assessment, HeritageNL identified a number of original rough sawn logs and tree nails, called trunnels. As examples of traditional and historic vernacular building methods both of these components contribute significantly to the character and heritage value of the building.

Image 6 (Bottom): Close up view of trunnels in foundation (Photo by Dale Jarvis, 2020)

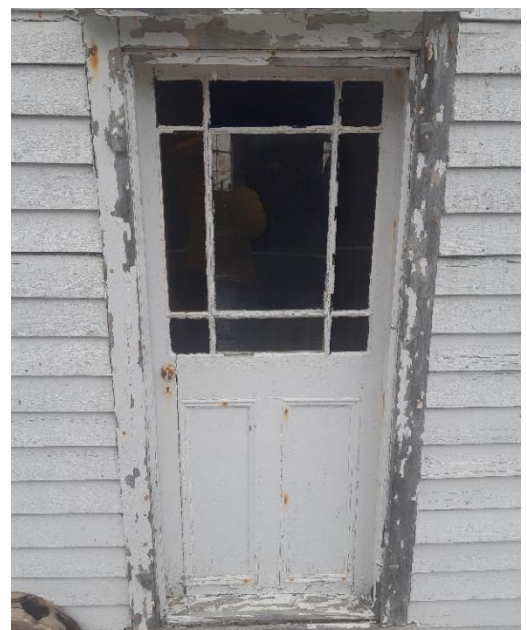
Between the time of the initial inspection in 2020 and renovations in 2021 the state of the exterior clapboard had deteriorated and was in clear need of repair. The clapboard on the western gable end of the building was in particularly poor condition.

Image 10 (Top): View of clapboard prior to restorations. (Photo by Bill Barbour, 2020)

Image 11 (Middle): First story window close-up. (Photo by Bill Barbour, 2020)

Image 12 (Bottom): Exterior door and door frame prior to restorations (Photo by Bill Barbour, 2020)

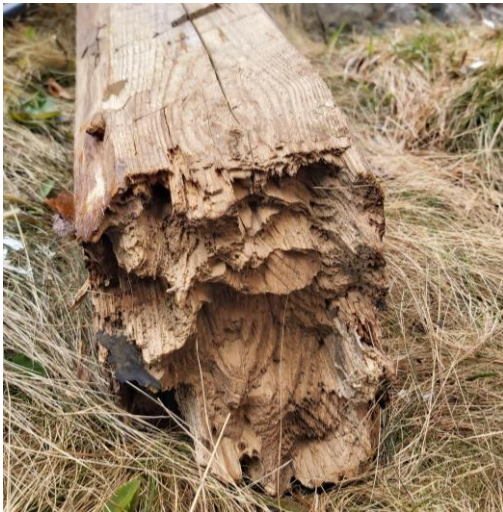
As noted in Barbour Service's initial assessment the majority of shores were severely rotted (see top left image), which had caused a great deal of uneven settlement and warping in the building. To address both of these issues, the building was raised and levelled before any shores were replaced. Where possible, trunnels (tree nails) used in the older foundation construction were preserved (see Image 14, left).

Image 13 (Top): Image of the rotten bottom of a removed foundation shore. (Photo by Maryssa Barras, 2021)

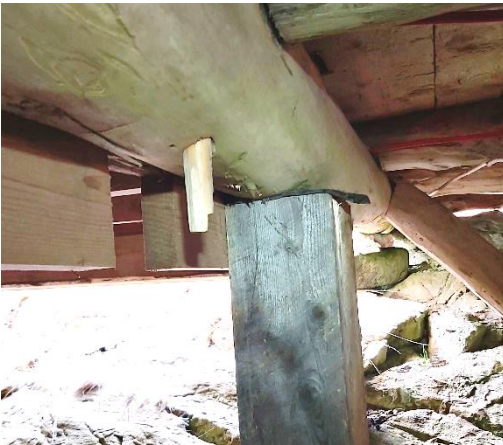
Image 14 (Bottom): Image of preserved sleeper and trunnel (Photo by Maryssa Barras, 2021)

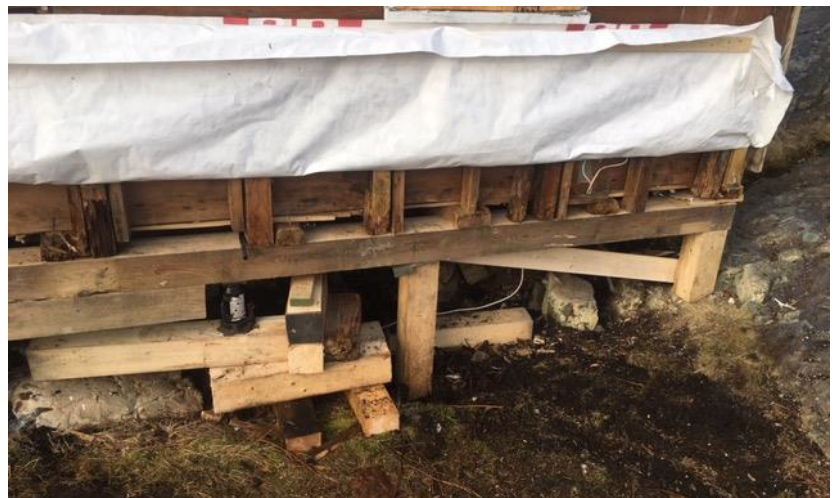
Image 15 (Right): Image of new foundation shores during installation and levelling (Photo by Barbour Services Inc, 2021)

Barbour Services started work on the foundation in late April 2021. Structurally, foundation work needed to be addressed first and foremost to stabilize and level the building's floors and walls before any construction was completed. Given the dire state of the majority of the foundation a great deal of structural elements could not be preserved but, keeping in line with the *Standards and Guidelines for the Preservation of Historic Places*, the only historic elements replaced during renovations were those which could not be saved or salvaged. In accordance with the *Standards and Guidelines* local lumber milled by two of the project workers in Lumsden was used, where possible, with the exception of a large 6x8 beam installed on the front sill of the building.

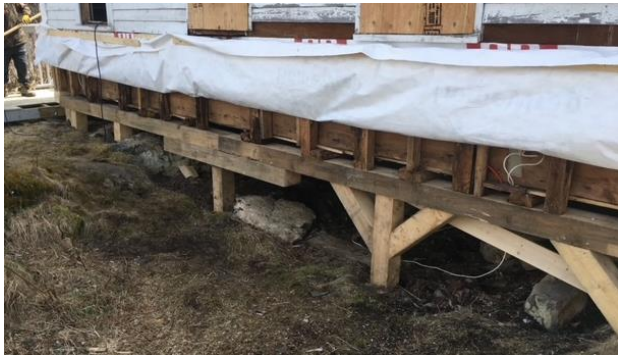
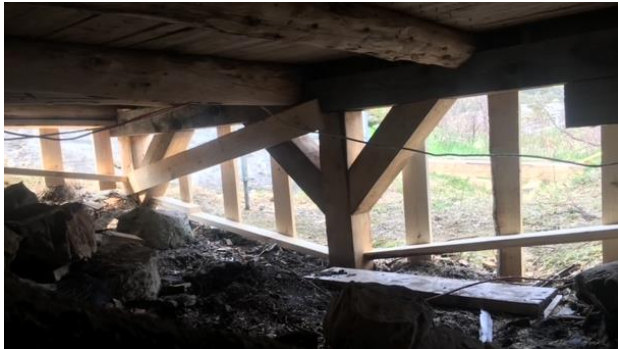
Image 16 (Top): Exterior view of replaced front foundation shores and sill (Photo by Barbour Services Inc, 2021)

Image 17 (Middle): View from interior of replaced front foundation shores and sill (Photo by Maryssa Barras, 2021)

The most dramatic renovations to take place were, predictably, to the front ocean facing façade of the museum building. This façade of the building is generally exposed to the most wind, rain, snow drifts, etc. which all increased the deterioration of the foundation. None of the six the shores along this edge of the building were original, although exactly when they were installed was unclear. All shores were all resting on large lain stones and were completely rotted at their base. The sill had previously been replaced sometime during the 20th century and was in very poor condition. The deterioration was so bad, in fact, that the carpenters noted they were surprised the front edge of the building hadn't collapsed yet. As a result of this, the entirety of the front foundation of the building was removed and replaced.

In order to help prevent future deterioration of the foundation along the front of the building new shores installed were embedded one to two feet below ground, directly on bedrock. Additional cross beams were lined across the front foundation of the building to better distribute loads and to strengthen the overall construction. Grey vertical plank skirting was later installed along the building's foundation.

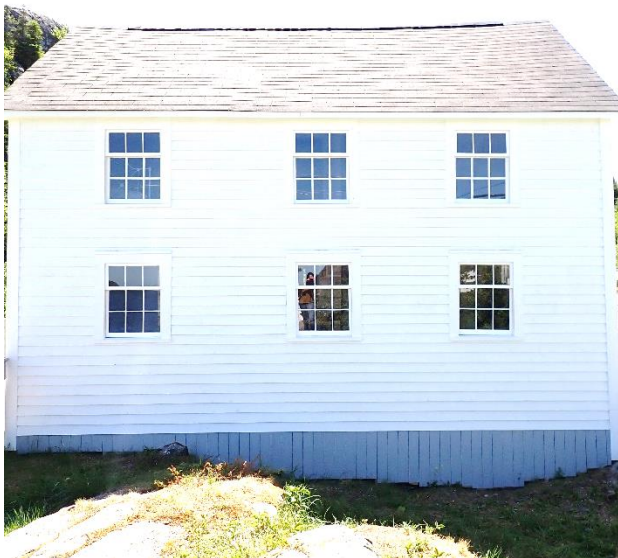
Image 18 (Bottom): Image of the completed vertical skirting (Photo by Maryssa Barras, 2021)

The SFMC had some discussion about whether to install vertical or horizontal skirting. Some community members recalled the museum having horizontal skirting, and others recalled vertical. At the time of renovations the SFMC did not have access to any historic images of the museum which clearly showed the skirting. Horizontal skirting is unusual in heritage buildings like this and, across the town of Salvage, all comparable homes and buildings feature vertical board skirting. As a result of this, and in consultation with HeritageNL the museum committee opted to install vertical skirt boards. Subsequent community research undertaken after the renovations were completed revealed historic images of the museum show that the building had horizontal skirting in the 1950s, likely throughout the building's time as a home for the Heffern family (see Image 19, next page). As a result, future restorations should consider installing horizontal skirting.

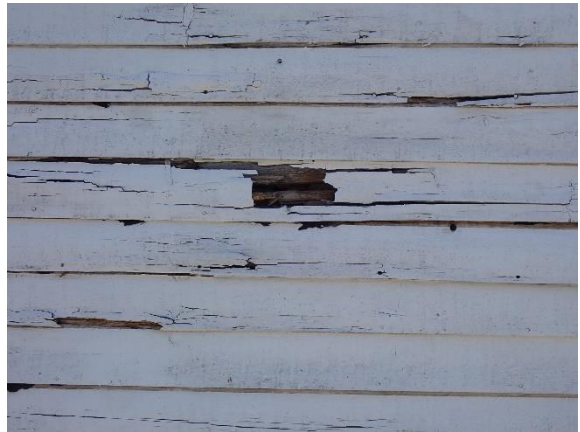
Overall, cladding and exterior wall components of the building were in far worse condition than was reported in 2020. The clapboard along the building hid some extreme rot and two different ant infestations along the front and east gable end walls. Corner boards were similarly all in very poor condition, and were unsalvageable.

Image 21 (Top Right): Damaged clapboard on the west gable end of the building (Photo by Maryssa Barras, 2021)

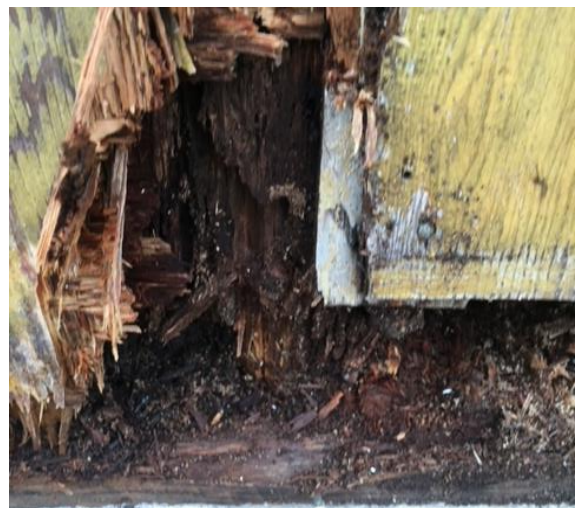
Image 22 (Middle Right): Close up of rot and ant damage on the front façade (Photo by Barbour Services Inc, 2021)

While the extent of the rot and ant infestations meant that a large portion of the building's sheeting needed to be replaced, the majority of the sheeting impacted was not historic, and had likely previously replaced sometime in the 1970s-90s. During renovations original sheeting from the late 19th century was found on the upper halves of the front/east gable sides and on the western side of the building. This older sheeting was found to be in good repair and was preserved by Barbour Services.

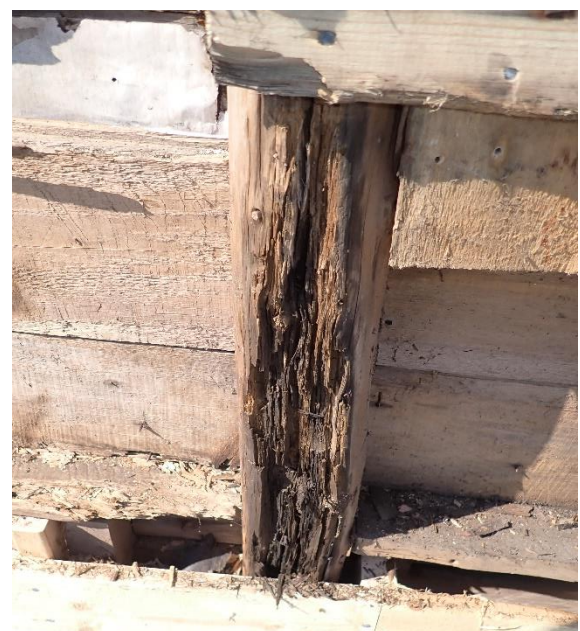
Image 23 (Bottom Right): Close up of original stud with surface rot (Photo by Maryssa Barras, 2021)

Studs on the east gable side of the building were all in a fair state, little intervention was required to preserve these. The studs across the front of the building appeared to be in poor states, with all studs showing clear evidence of rot. Fortunately, the rot was either superficial or only penetrated partway through the studs. As a result of this, Barbour Services contractors were able to preserve the original studs by adding supporting sister studs where needed.

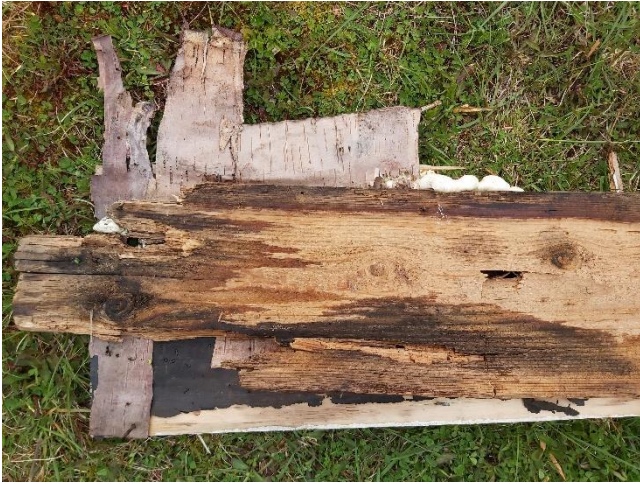
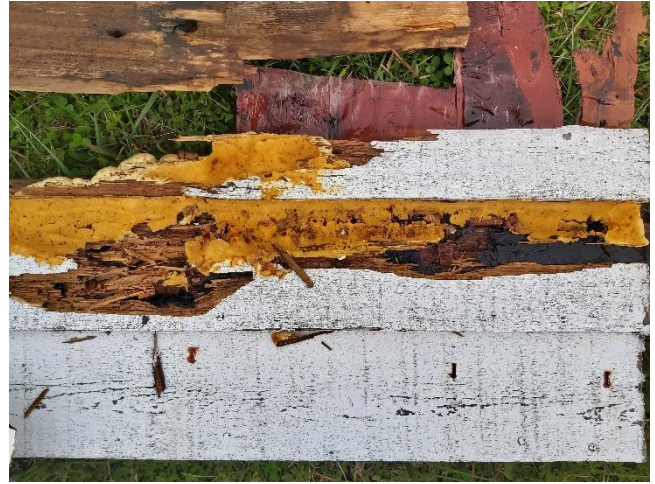
Image 24 and 25 (Top left and right): Close up of removed clapboard showing rot and past repairs (Photo by Maryssa Barras, 2021)

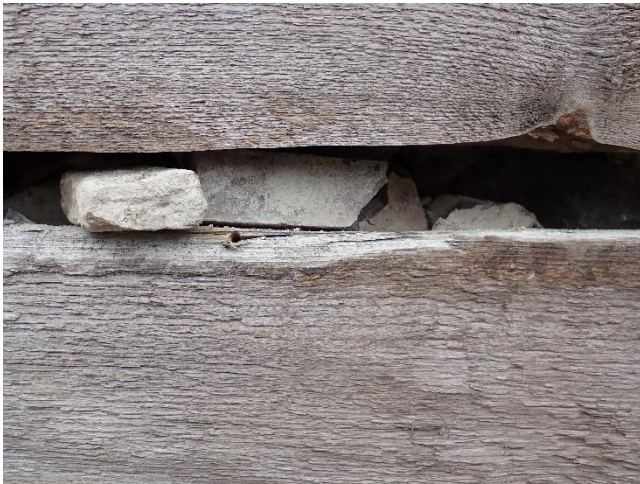
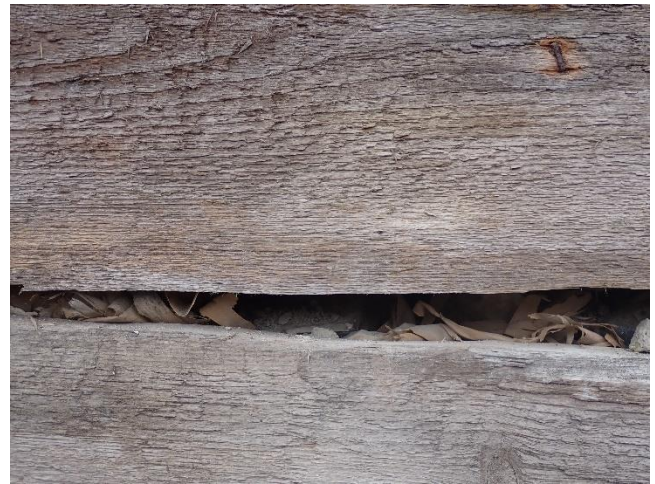
Image 26 and 27 (Middle left and right): Images of the loose stone fill through gaps in original sheeting from the chimney wall on the west gable end of the building (Photo by Maryssa Barras, 2021)

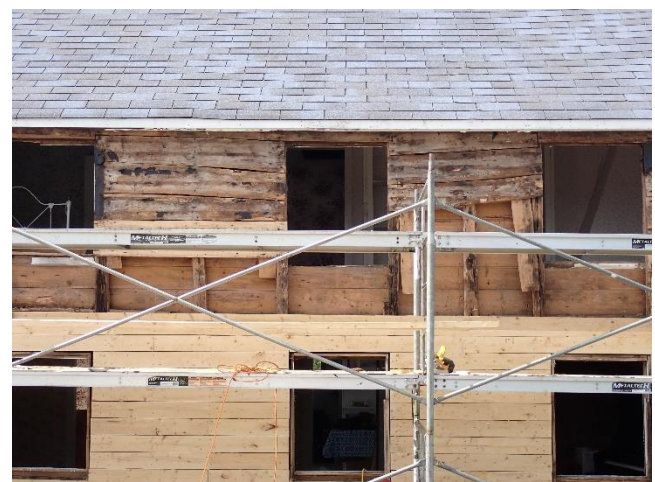
Image 29 (Bottom right): The front of the building with new sheeting installed on the bottom and original sheeting at the top (Photo by Maryssa Barras 2021)

Of all four sides, the front of the building was in the worst state. The vast majority of sheathing on this side of the building needed to be replaced. Underneath sheathing the studs on the front of the building suffered from a great deal of surface rot, although the studs themselves were still in great overall condition. Original studs were all preserved, and sister studs were added where needed for additional structural support.

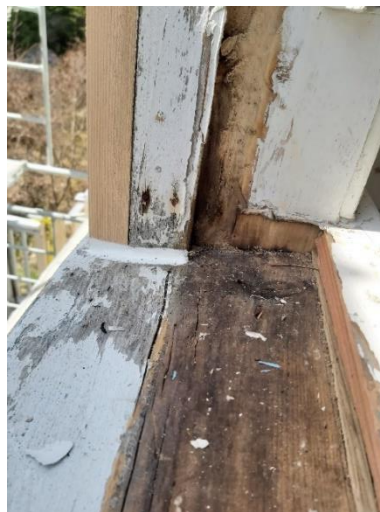
Windows were removed prior to any major work on the building and restored off site. The majority of window boxes across the building needed to be completely replaced as a result of extensive rot. Even in the least affected areas, rot had warped and degraded the wood to such a degree that it would be impossible to create a watertight seal. Where possible, elements of the older window framing was preserved. In total, only one window was preserved in its entirety (minus the exterior window box).

Image 35 (Right): Close up image of a window box prior to being removed which shows extensive rot and wear (Photo by Maryssa Barras, 2021)

Offsite, window units were repaired and restored by first scrapping and cleaning any areas of concern, then filling in gaps with wood putty to tighten loose frames. Once the frames were restored they were painted with three coats of linseed oil paint with added zinc. This paint had an unusually long drying time, taking nearly a week between coats to properly dry. As a result, some of the paint on the window frames is 'drippy' and uneven, and some of the new frames were painted with their final coats after installation. While imperfect, this uneven paint job is more authentic to the original aesthetic of the windows than perfectly even coats.

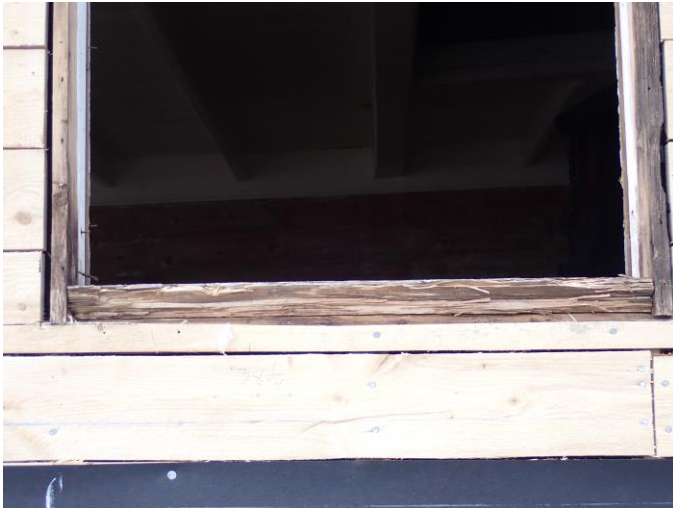
Image 39 (Middle left): Rot damage to first story window internal structure (Photo by Maryssa Barras, 2021)

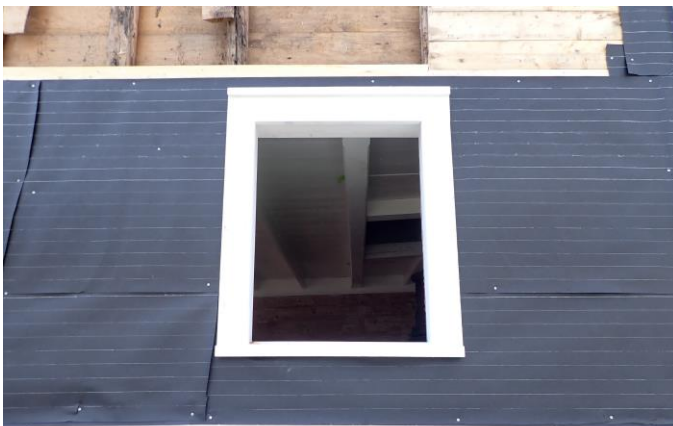
Image 41 (Bottom Left): Installed window box (Photo by Maryssa Barras 2021)

All exterior window boxes were not salvageable and had to be reconstructed. The exterior boxes were installed prior to clapboard over tar paper for a watertight seal, but the interior frames and windows were not reinstalled until after the clapboard was completely replaced. The exterior boxes were also caulked both before and after windows were installed, with a lower sill angled at a standard 10° to prevent water pooling.

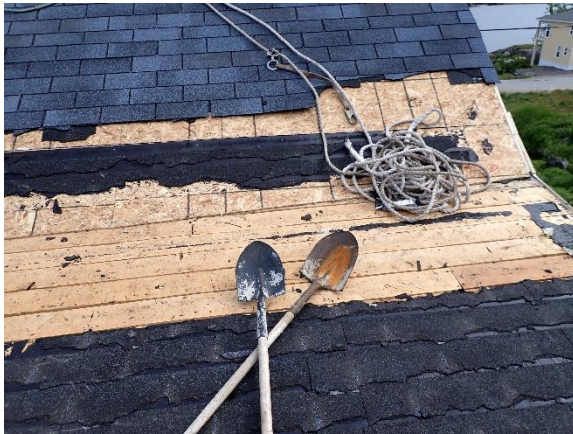
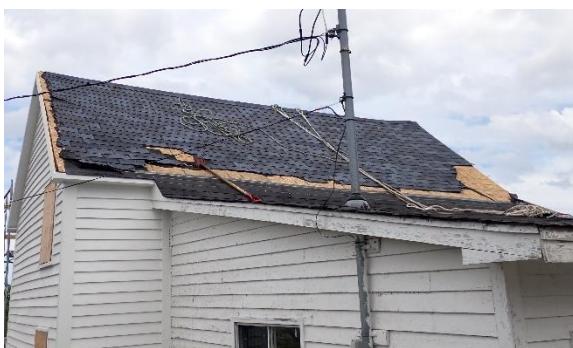
As mentioned in Barbour Services Inc's initial assessment, the roofing was in overall good condition. Some areas of concern included the joints between the old and new portions of the building, but these were found to be in excellent shape when roofing was removed. While cedar rather than asphalt shingles would not have been used on the original building, the Salvage Fisherman's Museum has sported asphalt shingles since at least 1948. Given the high cost of cedar shingles and the fact that the building has been covered with asphalt shingles for over 70 years, the SFMC in consultation with HeritageNL agreed that restoring the building with asphalt shingles would not reduce or take away from the building's character.

Image 46 & 47 (Middle and Bottom): Images of the roof undergoing restorations (Photo by Maryssa Barras, 2021)

The biggest alteration made to the roof is the addition of a new ridge vent, which was originally recommended by HeritageNL to promote proper ventilation through the building. The ridge vent has mildly impacted the integrity of the museum's roof line.
